**CERCLA
EXPANDED SITE INSPECTION ADDENDUM REPORT**

Eagle Zinc Company

Hillsboro, Montgomery county, Illinois

September 1, 2005

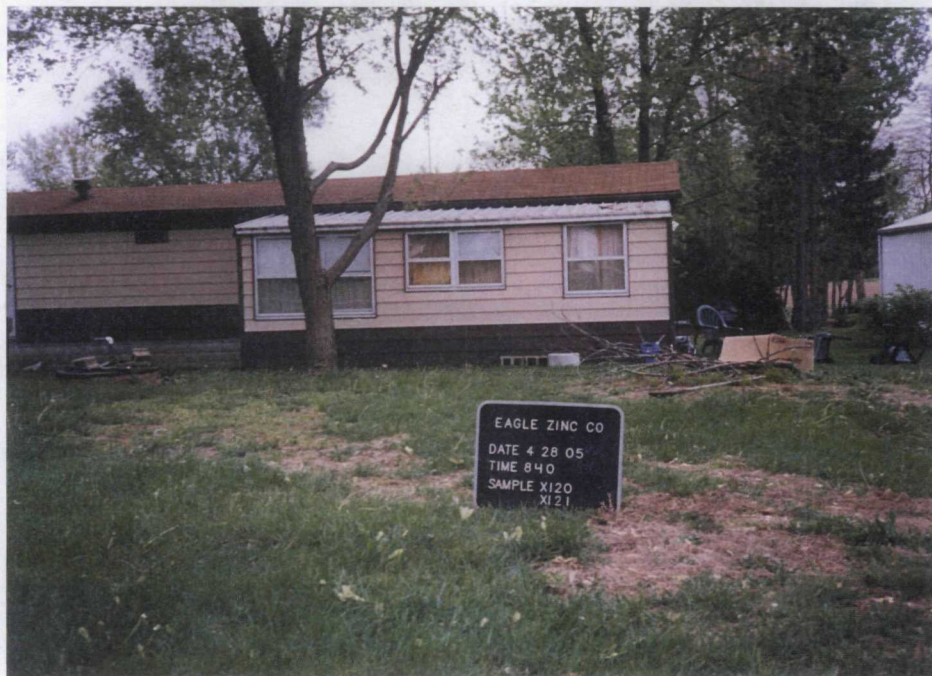
DATE: 4/28/05	SITE ILID#: 980606941	COUNTY: Montgomery
TIME: 8:40	SITE NAME: Eagle Zinc Co.	
PHOTOGRAPH TAKEN BY: R. Casper		
COMMENTS: Picture taken toward: East.		
Photo Number 76.		
Samples X120/X121		
were collected from		
a residential yard		
east of the site.

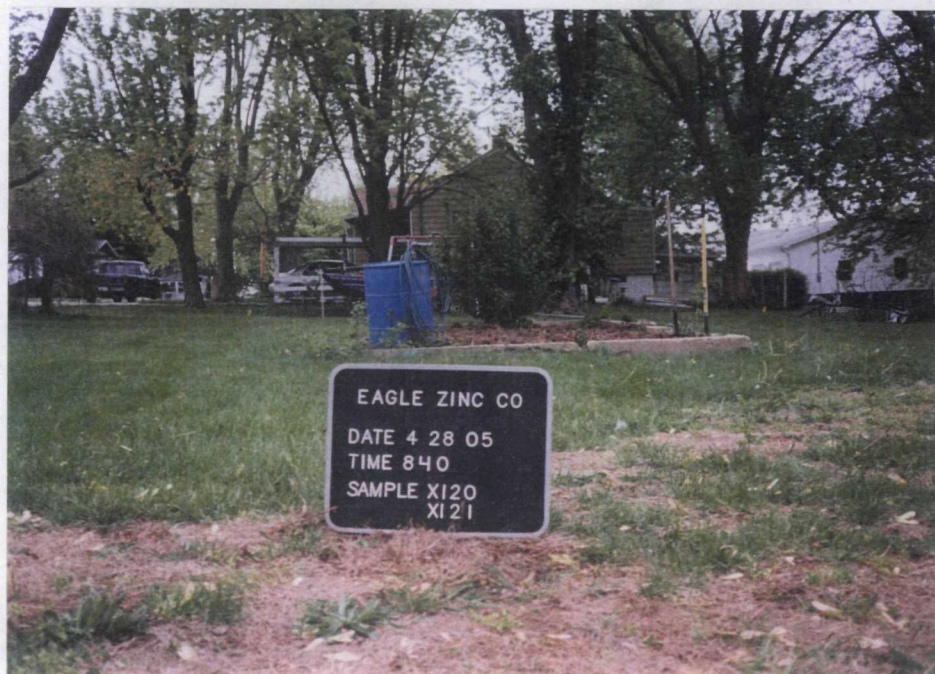
DATE: 4/28/05
TIME: 8:40
PHOTOGRAPH TAKEN BY: R. CASPER
COMMENTS: Picture taken toward: North.
Photo Number 77.
Duplicate samples
X120/X121 consisted
of a light brown
silty clay collect-
ed at a depth of
0 to 1 inch.

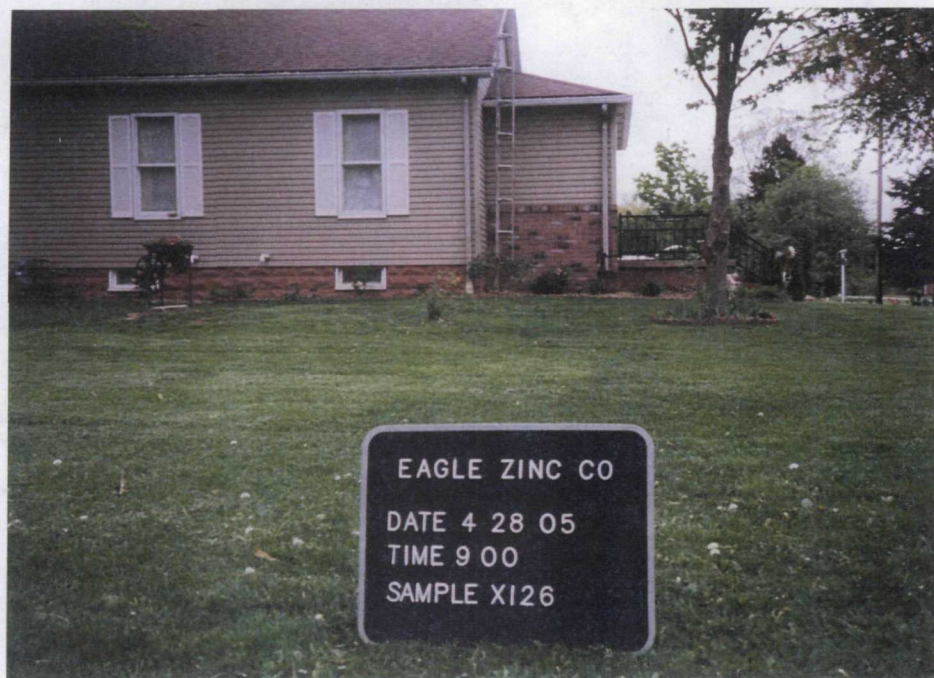
Photo Number 78.

Sample X126 was
collected from a
residential yard
southeast of the
site.

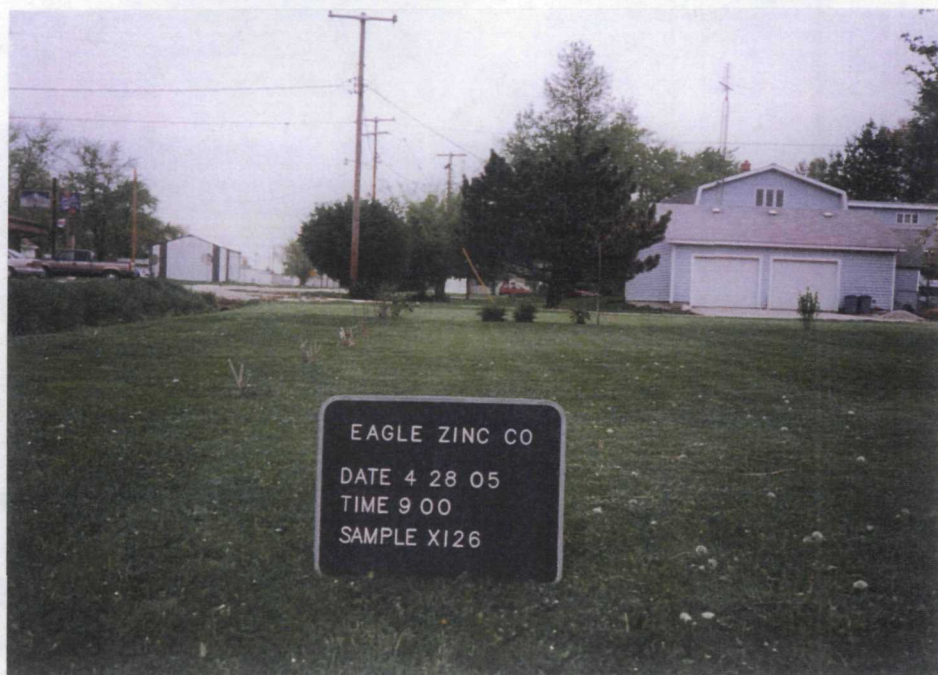
Photo Number 79.

Sample X126. The
sample consisted
of a black silty
loam collected at
a depth of 0 to 2
inches.

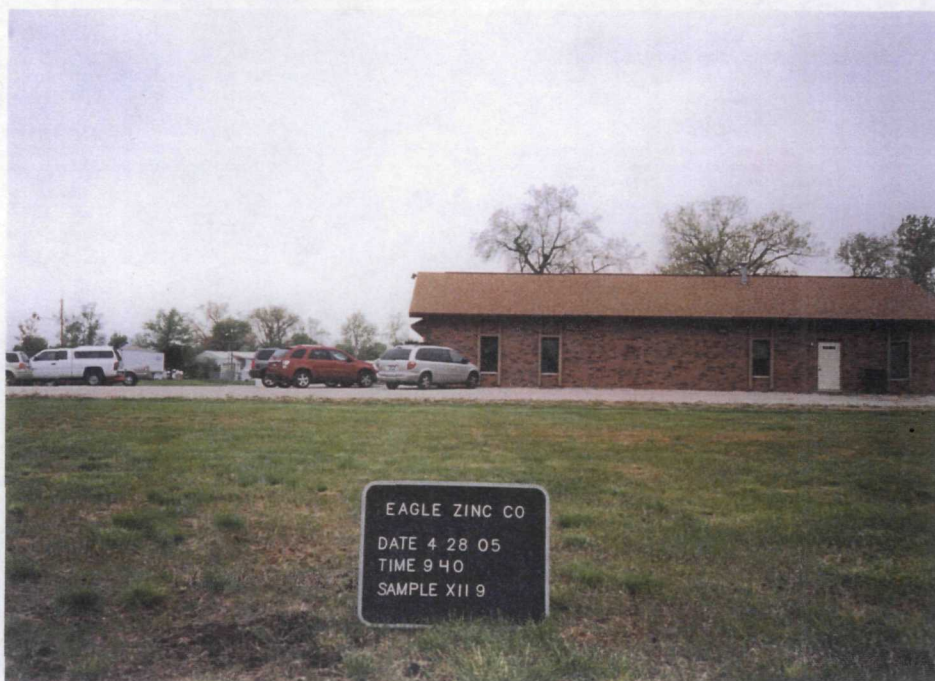
Photo Number 80.

Sample X119 was
collected from a
facility located
southeast of the
site.

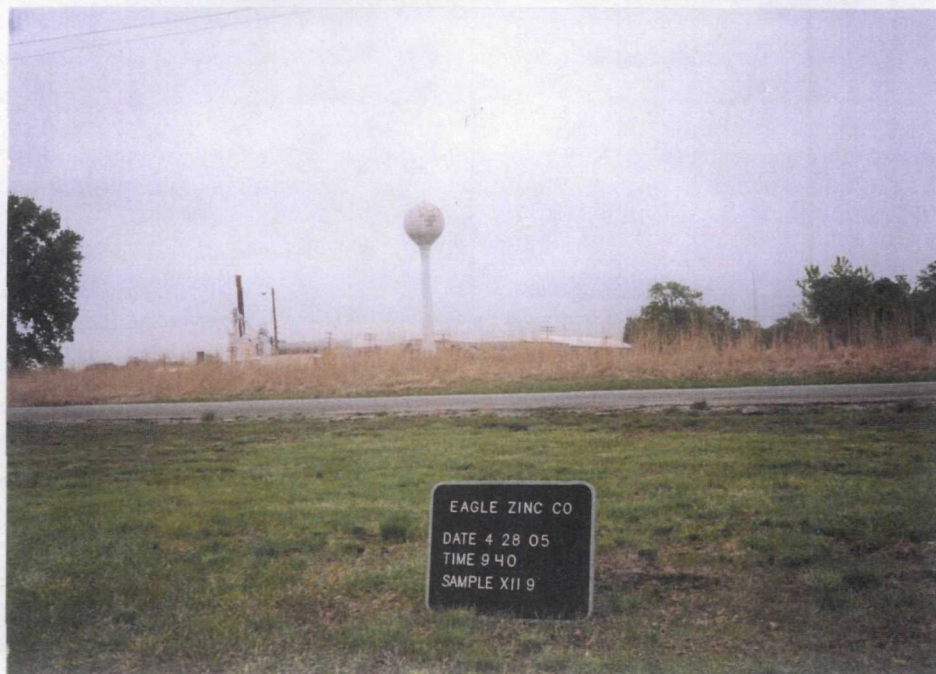
Photo Number 81.

Sample X119. The
sample consisted
of a black silty
loam collected at
a depth of 0 to 2
inches.
